# Be RainWise rebates for rain gardens & cisterns

Big Roof Case Study

## Community of Hope Church

# Community of Hope Church

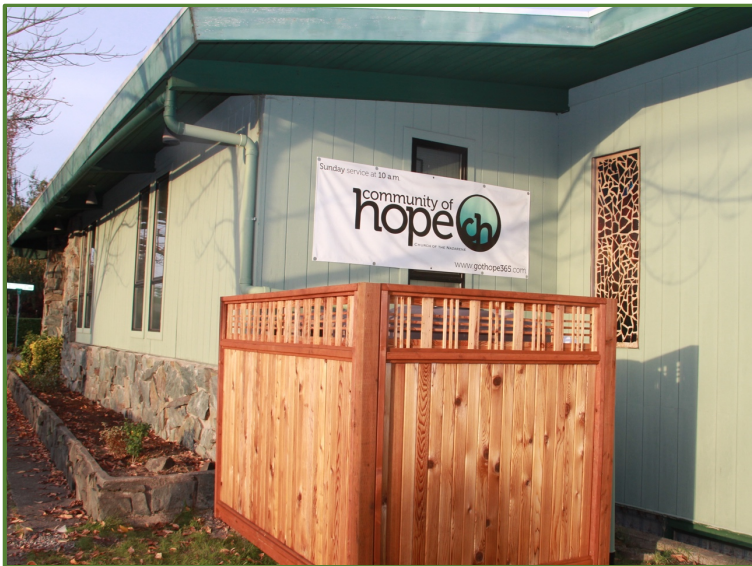
*Community of Hope Church in Highland Park has several cisterns, some of which are hidden with wood fencing.*

To make the installation more aesthetically pleasing and protect against possible damage, Rain Dog painted downspouts to match siding and added wood fence in front of each cluster of cisterns. The cisterns provide peak flow attenuation during winter months, draining slowly into the combined sewer/stormwater system. In the dry season, the cisterns provide irrigation storage capacity for landscaping.

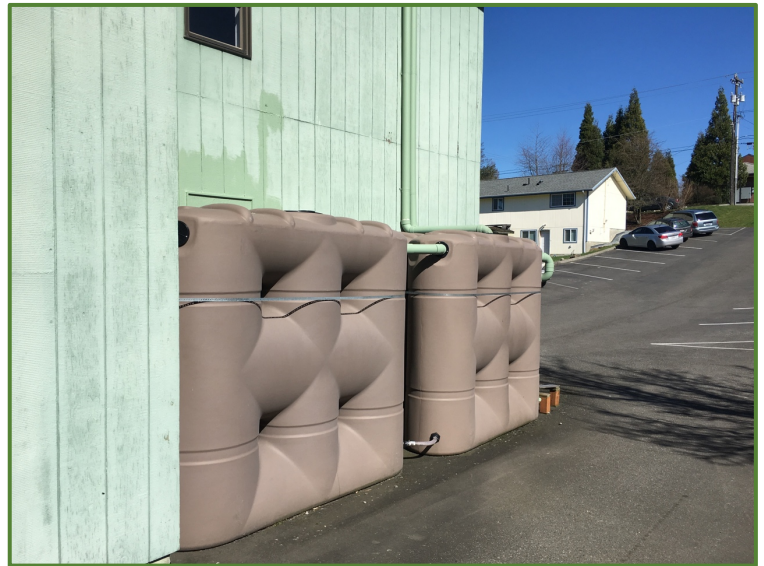
*There is a total of 12 cisterns around the building; all cisterns are of the slimline design.*

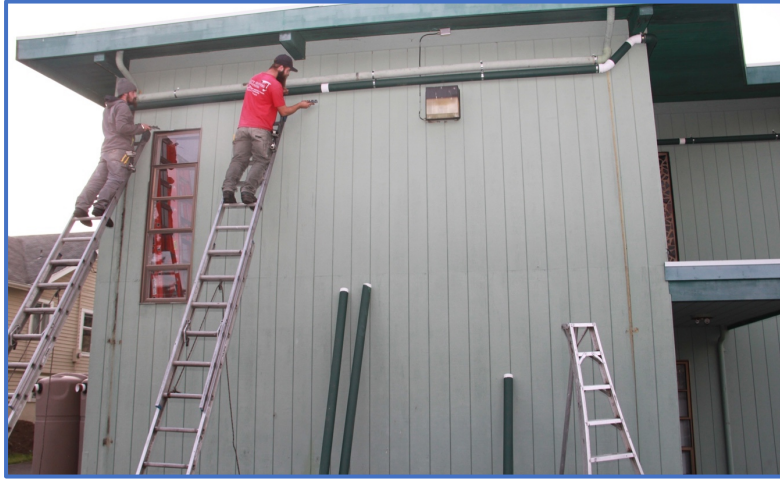
*Workers with Rain Dog Designs paint the downspouts to match the original color of the church building. This is one of many ways RainWise contractors can work with customers to personalize their installation.*

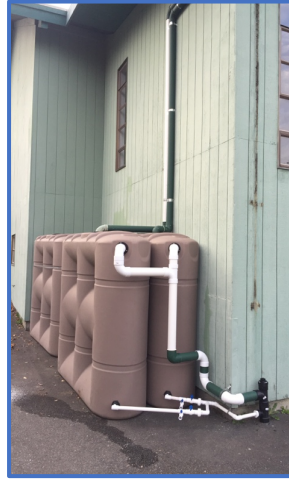
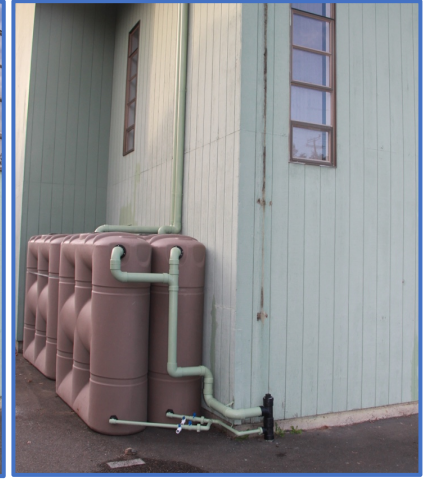
*Before and after the cistern pipes were painted. Cisterns are placed at different spots around the building in order to easily capture rainwater from the roof.*

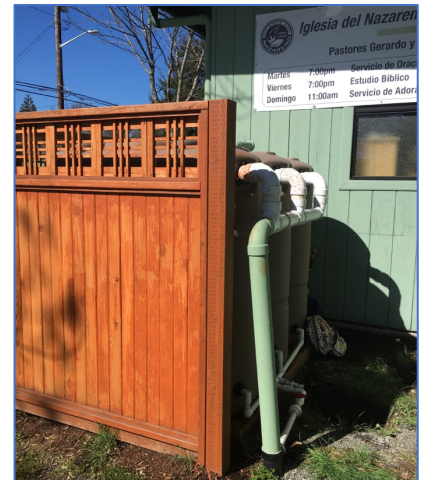
*Cisterns behind fencing.*
